History of Carriganass Castle

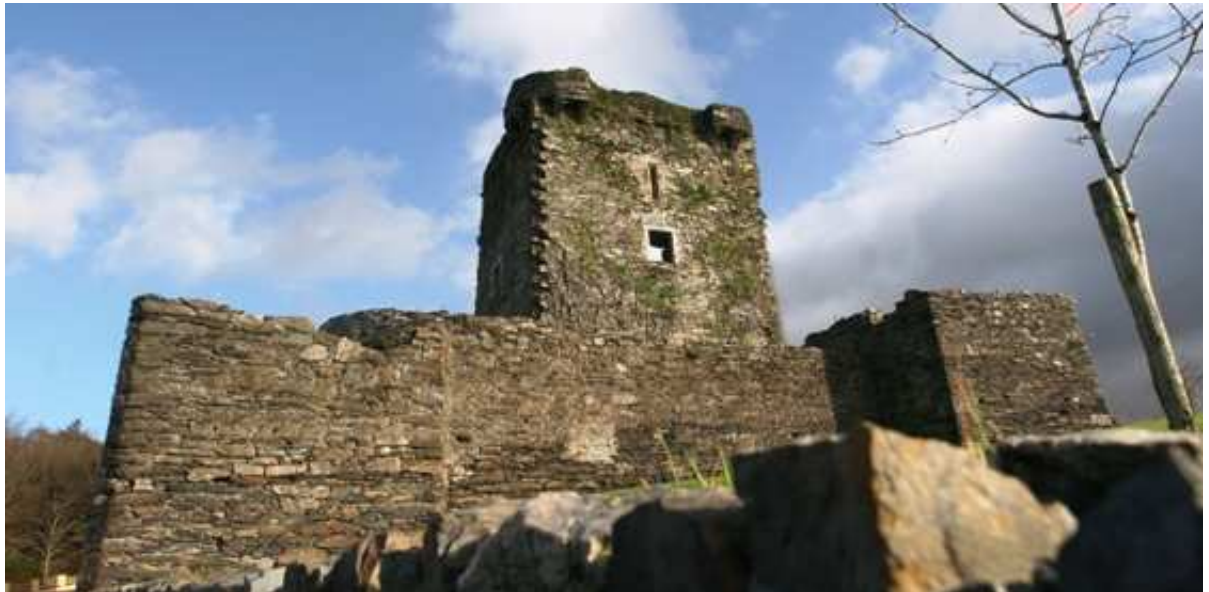
Carriganass Bawn

Refortification of existing buildings and construction of new fortified structures in the later part of the 16th century is a recurring theme in the study area. This process is most evident in the surviving architectural remains at Carriganass Castle. While the tower house here is clearly 15th century in date with later 16th century refurbishment. Its surrounding bawn wall is later. The bawn has been used as a farmyard over the last 150 years and has witnessed a significant amount of change and redevelopment. It has a substantial structure with an internal east west length of 42 metres and a north south width of 21 metres. This gives an overall internal space of 882 square metres which provides a useable area of about 730 square metres when you subtract the estimated 150 square metres that the tower house occupies. The bawn is roughly rectangular in shape and is positioned on an exposed east/west

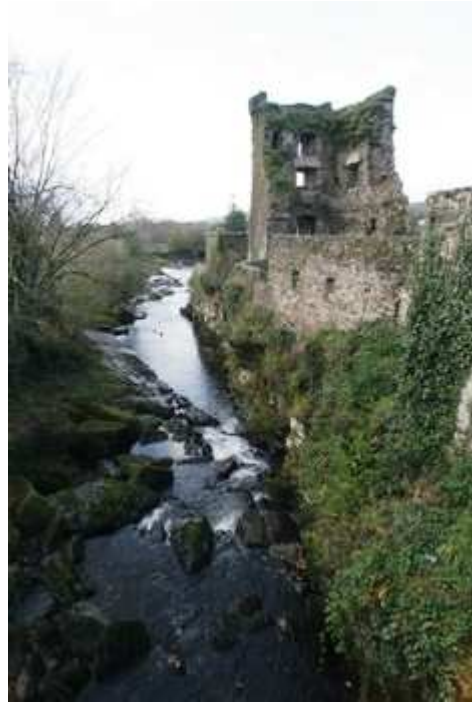
oriented bedrock ledge which runs directly adjacent to the Ovane River and its northern bank. It is a well built structure, constructed using an uncoursed rubble sandstone in a lime based mortar. In general this type of mortar was produced using sand and gravel from the local area in combination with lime putty. The putty was produced through the firing of limestone and later addition of water. The western wall is the best preserved running roughly north south for a distance of 13 metres between the south west and north west corner bastions and is 80 cm thick. It stands to a height of 4m above present ground level internally and displays 5 gun-loops with linteled embrasures. Its northern wall is best preserved at its western end where much of the original masonry still stands. This 27 metre long section sits directly on top of underlined bedrock with a substantial sandstone plinth visible externally. 7 gun-loops are visible in this section, each has well lintelled splayed embrasures with varying dimensions with averaging 50 cm by 50 cm in width and depth. The loops are now positioned at 1 metre above present ground level due to a build up of debris in the fort's interior but would have originally been positioned at shoulder level. There is a modern break in this wall towards its eastern end where the site owner has created an entrance. Most of its eastern sections is obscured by the presence of a modern farm building but traces of a chimney stack with what seems to be the springing of a small vault at its lower level can be seen. This may have been a bread oven incorporated into the chimney breast. The eastern wall is relatively featureless and stands at 4 to 5 metres high. It has a wide 3.2 metre break towards its northern end which is now blocked up but may originally have been the entrance into the bawn. An underlined plinth projects from beneath the structure for 20 to 30 cm at the north of the wall. A series of projecting stones can also be seen running up the wall on the southern side of the entrance which constitute the remains of a stairwell leading to a walled walk. Finally, the southern wall is the least well preserved with much of its western half now destroyed. It follows the natural line of the edge of the river cliff that it stands on

so it is not as linear as the other 3 walls. 3 large splayed windows which were originally lintelled are visible at ground level on the wall with traces of a fort blocked up example. These appear to be original windows which face southwards. The wider and more elaborate nature of these windows in comparison with the pistol loops which are present on the north and west wall indicate the greater sense of security that the occupants felt on this side overlooking the river. They must also represent the former presence of a domestic/administrative building abutting the wall at this position within the bawn. The presence of a vault which may have been part of a chimney stack at the western end of this section of a wall is further evidence of this. Indeed both stacks are clear indicators of the presence of a range of internal buildings that would have formally occupied the interior.

The bawn has 4 projecting spear shaped bastions or flanking towers. Each is stone built and consists of a ground and first floor level. While each of the bastions is broadly similar in shape and size each having an approximate internal area of 22 to 24 square metres, they differ in some respects. The south-east bastion has a very clear defensive function as exemplified by the presence of 6 pistol loops at ground floor level and 4 further examples on the east wall at first floor level but it does not simply serve this function. The presence of a large ground floor fireplace in the south-west corner of the building which was originally lintelled gives a sense of permanence about the occupation of the structure. It may have served as the main duty room for the soldiers in the bawn. A more domestic or utilitarian function is unlikely given the absence of other domestic fittings. The presence of a large splayed window on the south wall at first floor level is a further indication of the more utilitarian nature of this bastion. It continues the trend of placing walls in this wall in line with the 4 previously mentioned wall windows on ground level in the south wall.

The north-east bastion has been refurbished in recent years by the site's owner and all of the walls have been plastered and the first floor has been substantially rebuilt. This has masked the original character of the feature and makes any interpretation impossible. A number of gun-loops can however be identified on the exterior at ground floor level. Both of the western bastions are slightly smaller than the eastern examples having a rough internal area of 20 square metres and a more regularly shaped squared internal area. The north-west example is probably the most defensive of the 4 bastions. It is solidly built on 2 levels. Much of the ground is obscured by a build up of soil, rubble and farmyard debris. External examination reveals 2 pistol loops on either side of a narrow slit window on the northern face and 3 further loops on its western face. The south-western bastion has a regular squared interior with 3 pistol loops at ground level on its western face. The south facing wall is featureless. Interestingly the upper floor of this feature is covered with 4 tiers of small rectangular niches which would originally have served as nesting boxes. The niches are present on all 4 internal first floor walls and this level clearly served as a dovecote. The presence of the *côte* provides an indication of the diet of the inhabitants.

The bawn is clearly a late 16th century in date. While there is no documentary evidence to support this assertion there is clear cartographic and archaeological evidence. The mid 16th century map of Bantry and Beara previously mentioned shows the 5 tower houses in the bay, all shown with enclosing bawn walls with the exception of Carriganass. The accuracy of this source is already been attested to and the omission of a bawn is clearly indicative of the absence of such a feature at this date. Secondly the presence of gun-loops is a clear chronological indicator of a later 16th century build. The Cork survey has noted that the introduction of gun-loops is a later 16th century phenomenon on West Cork tower houses and castles. The

numerous gun-loops on the bawn then support this assignation of a later date. Finally, the spear shaped bastions are probably the most convincing indicator of a later build. The fashion of star shaped construction was developing rapidly across Europe by the end of the 16th century and the adoption of this architectural development of Carriganass demonstrates the contemporary approach to defence that Owen O'Sullivan was adopting. However the bawn was built without provision for large guns/cannon. There are no breaks in the wall which would have acted as gun positions and the bastions have no visible emplacements for guns. This indicated O'Sullivan did not own or have access to this type of artillery. It is also indicative of the limited role this type of equipment played in conflict in the region during the preceding century. This limited association with cannon is further demonstrated by the use Donal Cam made of European military experts and their cannon during the course of the 1602 siege. It appears from both of these examples that the Gaelic lordship simply had nothing to do with cannon until 1601-1602.
